# ELECTRICAL INFRARED THERMOGRAPHY REPORT

**SANITIZED SAMPLE - ACTUAL FIELD FINDINGS**

**Prepared by:** Guardian Predictive Solutions (GPS)

**Service:** Electrical Infrared Thermography / Predictive Maintenance

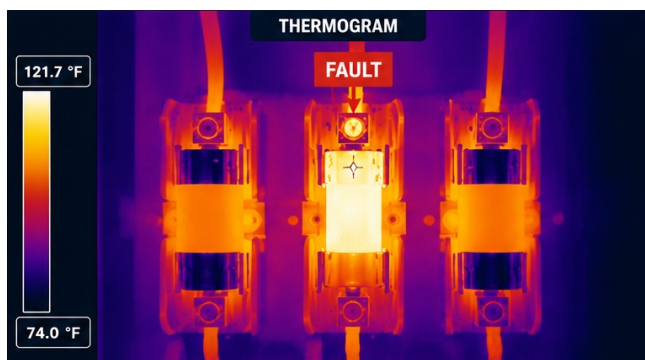
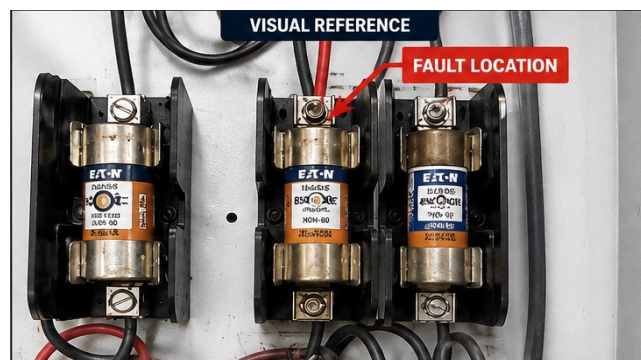
## FINDING 01 - B-PHASE LOAD-SIDE CONNECTION

| Finding | Elevated thermal condition at B-phase load-side connection |
| Fault temperature | 120.2 °F |
| Reference temperature | 107.7 °F |
| Delta T | 12.5 °F |
| Severity | MINOR |

| POSSIBLE CAUSE | RECOMMENDED NEXT ACTION |
|---|---|
| Loose, contaminated, or oxidized termination may contribute to elevated heating at the fused-disconnect B-phase load-side connection. | Have qualified personnel evaluate the connection. As appropriate, de-energize using approved procedures, disassemble, clean and tighten component(s), check surrounding components for damage, and review circuit loading / balance. |

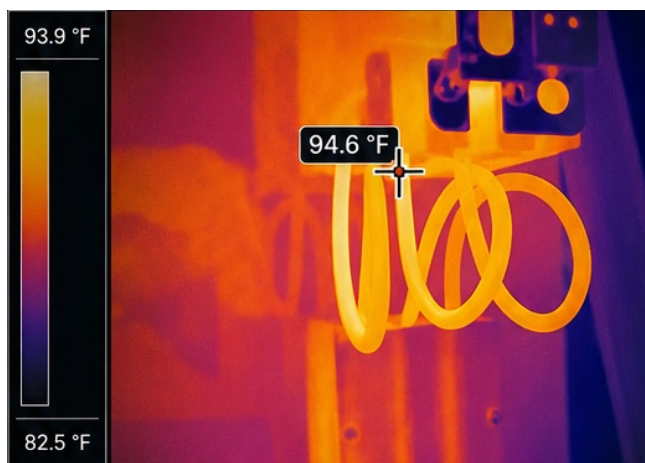
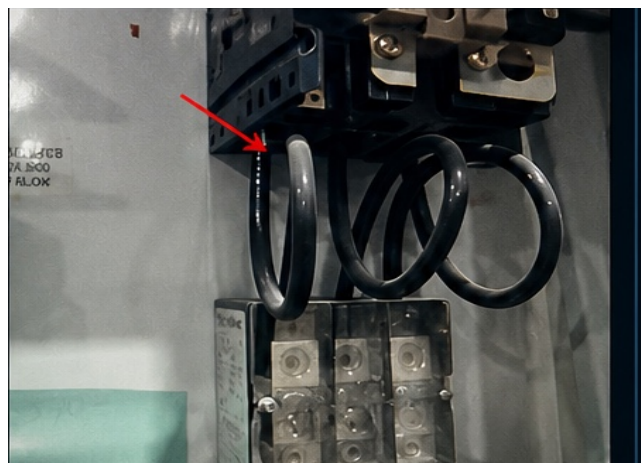
## FINDING 02 - A-PHASE LINE-SIDE CONNECTION

| <b>Finding</b> | Early-stage elevated heating at A-phase line-side wire lug |
| <b>Fault temperature</b> | 94.6 °F |
| <b>Reference temperature</b> | 92.0 °F |
| <b>Delta T</b> | 2.6 °F |
| <b>Severity</b> | MINOR |

| <b>POSSIBLE CAUSE</b> | <b>RECOMMENDED NEXT ACTION</b> |
|---|---|
| Loose, contaminated, or oxidized connection may contribute to the observed early-stage resistive heating at the A-phase line-side wire lug. | Monitor and have qualified personnel evaluate the connection. As appropriate, de-energize using approved procedures, disassemble, clean and tighten component(s), inspect surrounding components for damage, and review circuit loading / balance. |
